Reliable Home Inspection

HOME INSPECTION REPORT

123 Spring Street
Our Town
U.S.A.70123

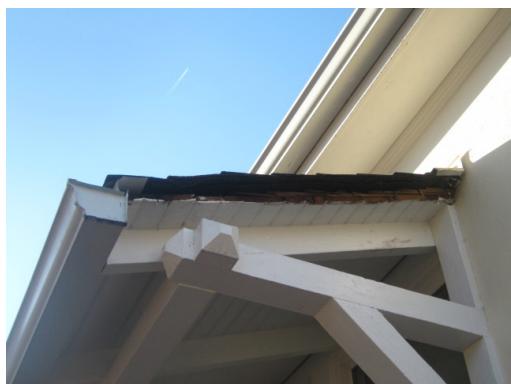
- Fascia and Trim 1.4.01 - There is a piece of trim missing from the side of the rear porch overhang. I recommend replacement of the missing trim.

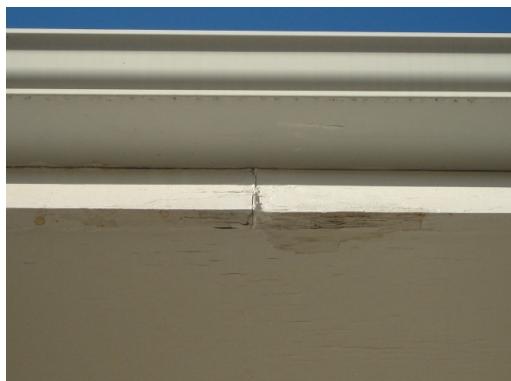
- Eaves and Soffits 1.4.02 - Water stains were noted under the roof overhang at the south side of the master suite section of the residence, which is an indication that the roof has been leaking at the edge flashing (see roof section for other recommendations.) I recommend repair/repainting of the fascia board. There could be additional damage beneath that was not visible during the inspection.

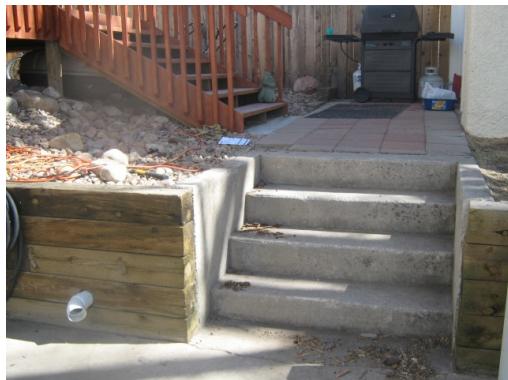
Detached Steps 1.1.01 - As a safety precaution, we recommend installing a handrail at the concrete staircase at the rear driveway area of the property.

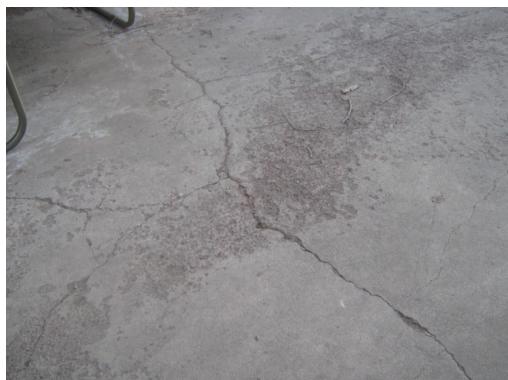
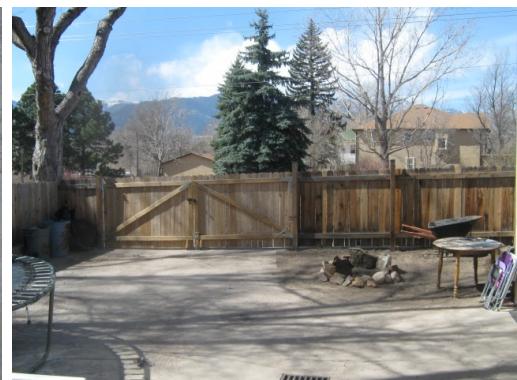
Driveway

1.3.01 - The concrete rear driveway is functional but has some cracks. These cracks have been repaired in the past. I advise cleaning and refilling/sealing the cracks to preclude water intrusion.

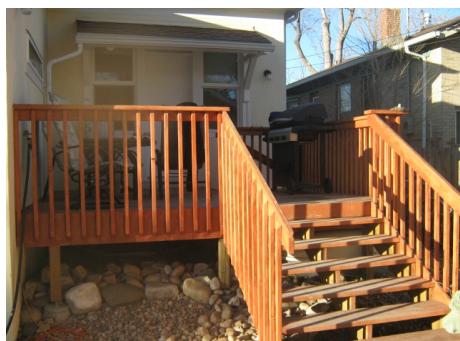
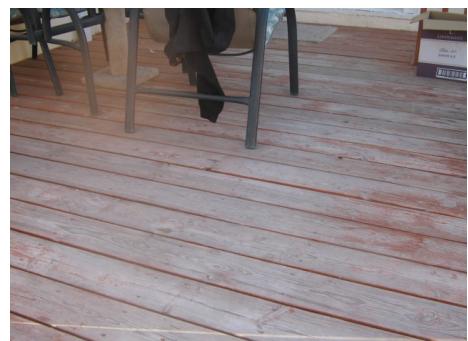
Decks and
Balconies

1.4.04 - The wood deck at the southeast corner of the house needs painting or sealing to help extend its lifespan.

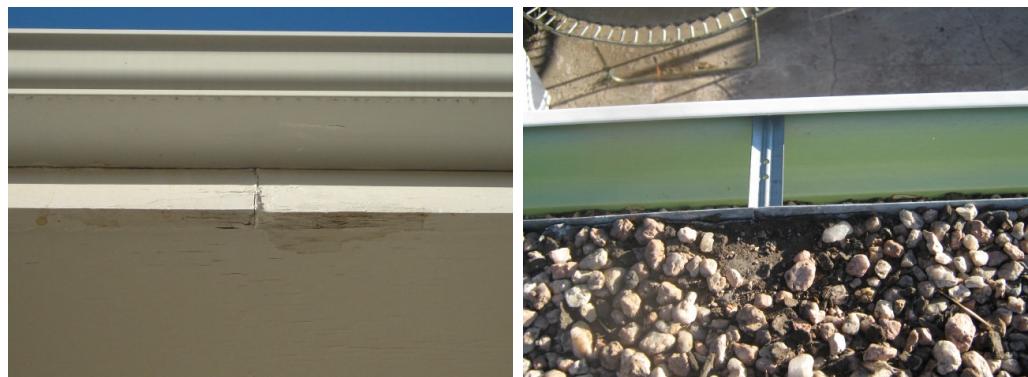
Flashings	3.1.01 - The roof flashing at the south edge of the flat roof has a loosened overlap section that is leaking and is probably responsible for the moisture staining at the south soffit board area beneath. I recommend a licensed roofer evaluate the entire flat roof section and perform all required maintenance to preclude water intrusion.
-----------	---

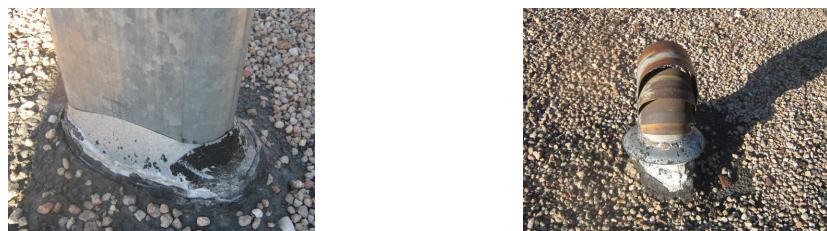
Protrusions	3.1.02 - There are two vent pipes at the flat roof section that no longer serve a purpose. The vent pipes are poorly sealed and could be leaking, and one of the pipes has the storm collar positioned too high to be effective. I recommend a licensed roofer remove both vent pipe installations and restore and seal the roof to match surrounding conditions.
-------------	---

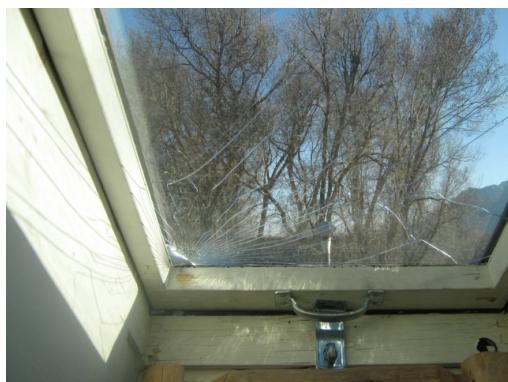
Skylights

3.1.03 - There are cracks in the skylight at the south side of the roof. I recommend replacement of the cracked glass by an appropriately qualified specialist.

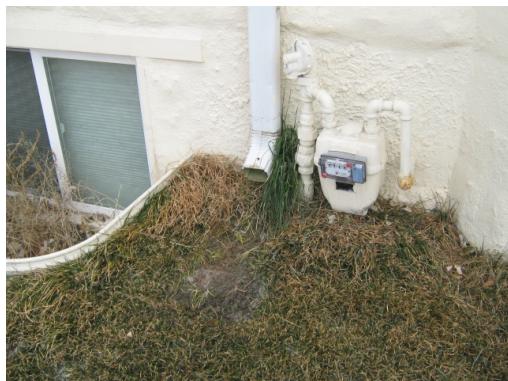
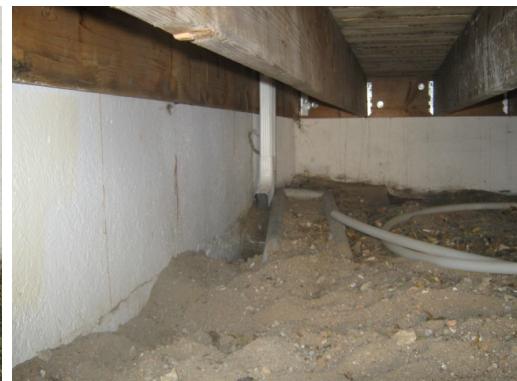
Roof Drainage

Moisture and Dampness 2.3.01 - There is dampness along the basement bedroom west wall/floor area. There is a downspout immediately to the exterior of this location whose splash block has been removed. See Roof section for downspout corrective information.

3.1.04 - There is a splashblock beneath the deck that is poorly positioned and the uncontrolled downspout water is causing soil erosion against the garage foundation wall. There is another splashblock on the west side beside the basement bedroom window that has been removed apparently to mow the lawn but was not replaced and the uncontrolled downspout water appears to be the cause of the moisture in the basement. I recommend permanently installed 4' downspout extensions at both locations in order to help divert water away from the foundation.

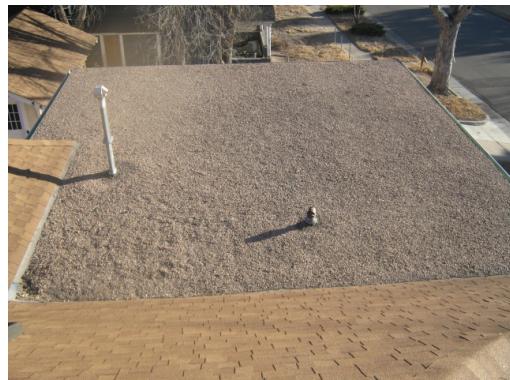
Built-Up Gravel 3.1.06 - Water stains in some areas on the flat roof section are an indication that water has pooled in the past and will continue to pool, and it will be important to keep this roof clean and have it inspected on a regular basis. The flat roofing materials are about 12 -14 years old.

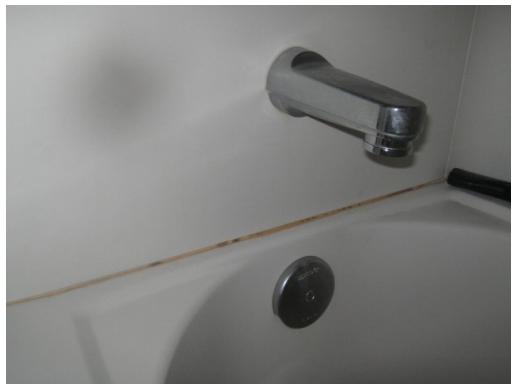
Tub-Showers 5.3.02 - The water faucet valve handle is loose at the hall bathroom tub-shower and needs service.
5.3.03 - Caulking is needed along the base of the tub-shower in the basement bathroom to help prevent possible water damage .

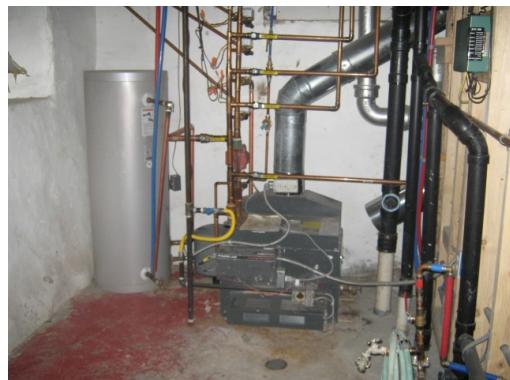
- Heating System 6.1.01 - The boiler does not appear to have been serviced recently. I recommend a thorough cleaning/servicing of the boiler system.

- Heating System 6.1.02 - The installed 14 -16 year old hydronic radiant heating system uses a 225,000 BTU Teledyne-Laars gas boiler to heat water and an electric pump to circulate it through PEX tubing under the floor to radiators on walls beneath windows. There are 4 separate heating zones with a priority domestic hot water zone. The boiler is located in the basement utility room.

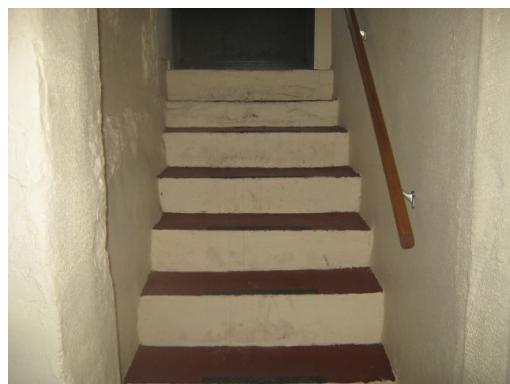
Treads and Risers 8.4.01 - The riser height of the basement staircase is not uniform and therefore represents a potential trip or fall hazard. The rise is the measured height from one step to the next, and the difference in rise from one step to the next should not exceed three-eighths of an inch. I recommend correction by a contractor.

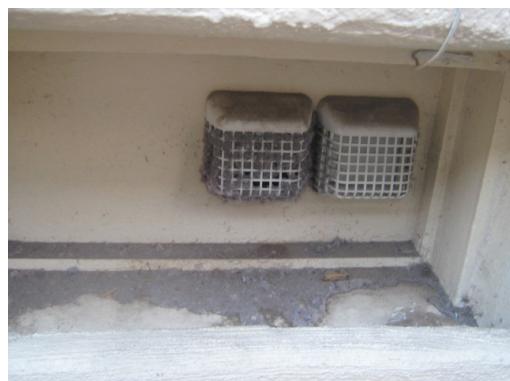
Dryer Venting 8.6.02 - Both dryer vent end caps are becoming clogged with lint. It is important that the dryer vent screen (lint trap) be kept in place and clean, because lint that bypasses the trap and enters the duct can block the duct, presenting a fire hazard. The duct should be periodically cleaned and checked for blockage.
