Reliable Home Inspection

HOME INSPECTION REPORT

123 Spring Street
Our Town
U.S.A.70123

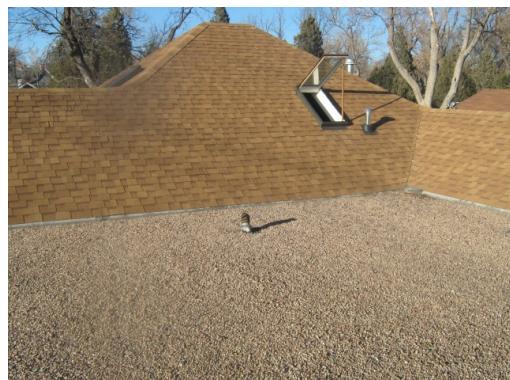
| Composition Shingle | 3.1.09 - The composition shingle roofing material on the pitched section appeared to be in satisfactory condition and is about 3 years old. The roof was walked on for the inspection. |

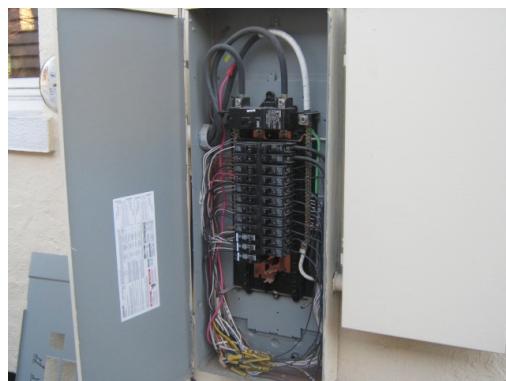
Main Panel 4.2.01 - The residence is served by a 200 amp, 240 volt main panel, located at the east side exterior wall of the residence.

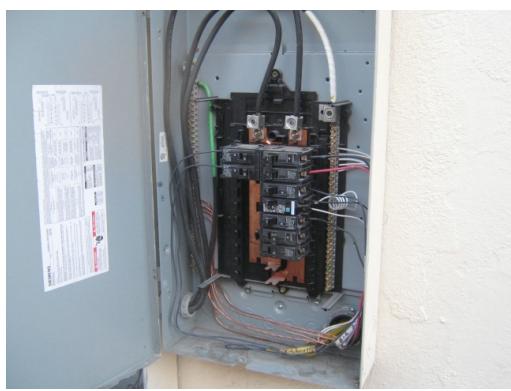
- Main Disconnect 4.2.02 - The 200 amp main disconnect is located inside the main panel.
- Grounding 4.2.03 - The main electrical panel is double-grounded to a driven rod and to a water pipe.
- Circuit Breakers 4.2.04 - There were no visible deficiencies with the circuit breakers in the electrical main or sub panels.
- Sub Panel 4.3.01 - There is a 100 amp, 240 volt sub panel located at the south side of the residence. This panel serves the basement apartment.

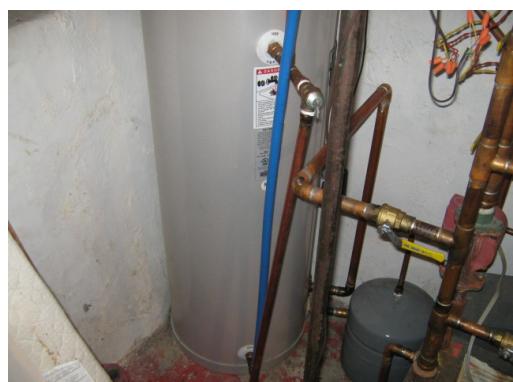
Water Heater 5.4.01 - There is a 2 year old, 45 gallon, indirect, sidearm water heater located in the utility room.

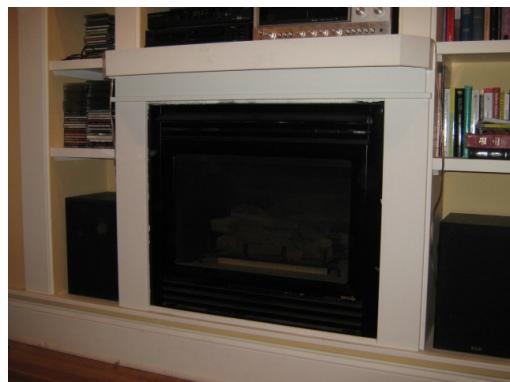
Fireplace 7.1.01 - The living room fireplace and chimney system is a single-story, direct vented gas appliance, manufactured by HEAT N GLO, and is designed for use with gas only.

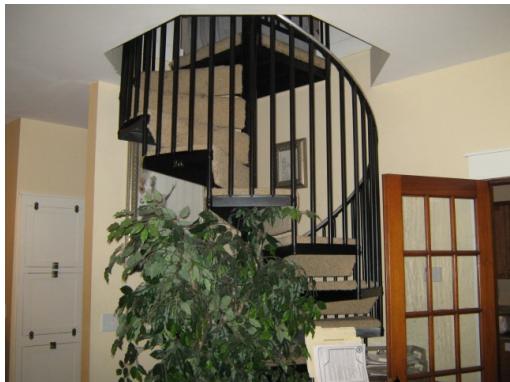
Stairs 8.4.02 - The spiral stair system leading to the attic bedroomappeared to be in satisfactory condition.

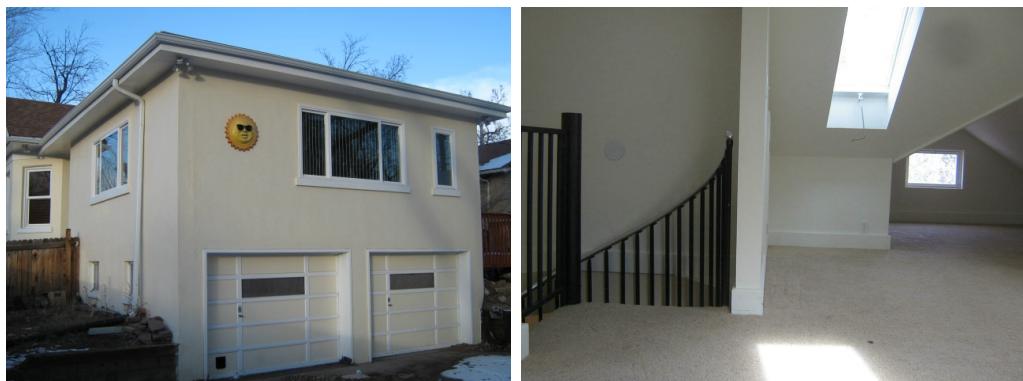
10.1.01 - The master suite/garage is an addition built in 1959 and the attic bedroom was converted in 2007 along with a major remodel of the entire residence.

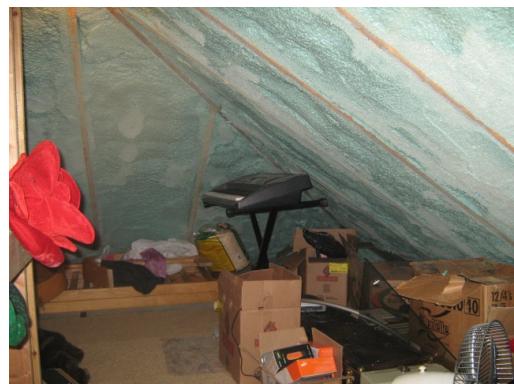
11.1.01 - The roofs in the main section and in the master section are insulated with approximately 6 inches of polyurethane foam insulation, which provides an R-38 thermal value. The laundry area is insulated with R-38 fiberglass batts.
